Ministry of Transportation  
Environmental Guide for Fish and Fish Habitat

Section 4: Field Investigations  
Appendix 4.A: Watercourse Field Record Form

## Photolog

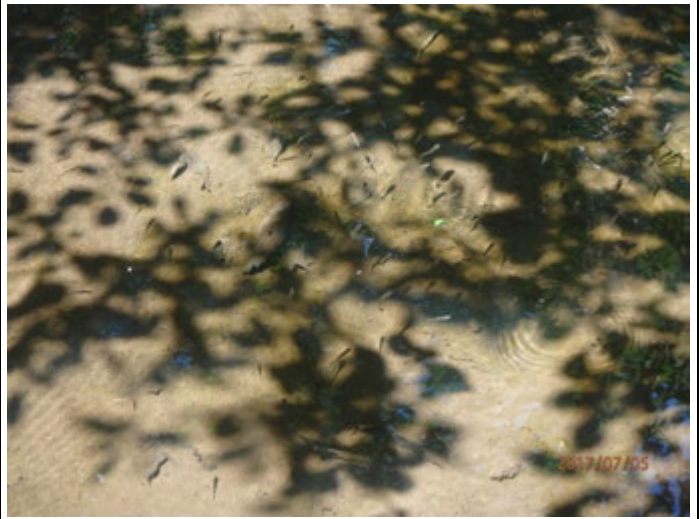
**Photograph 14. ↑**

Young of the year (YOY) fish in Site 401-6-05 downstream of 401 East; spawning substrates present.

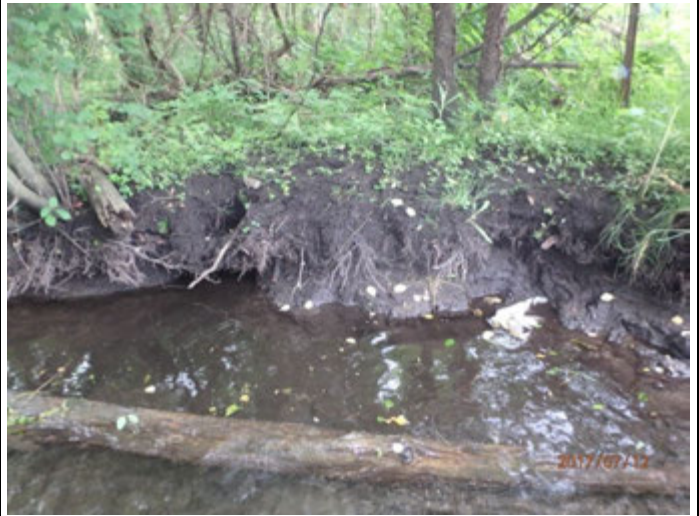
**Photograph 16. ↑**

Eroding banks in Site 401-6-05 upstream of 401 East.
